Portage Creek Sediment Remediation Project Kalamazoo, Michigan

Post-Sediment Removal Structure Feature Assessment Removal Area SA3-A

FLEIS & VANDENBRINK
ENGINEERING, INC.

August, 2013

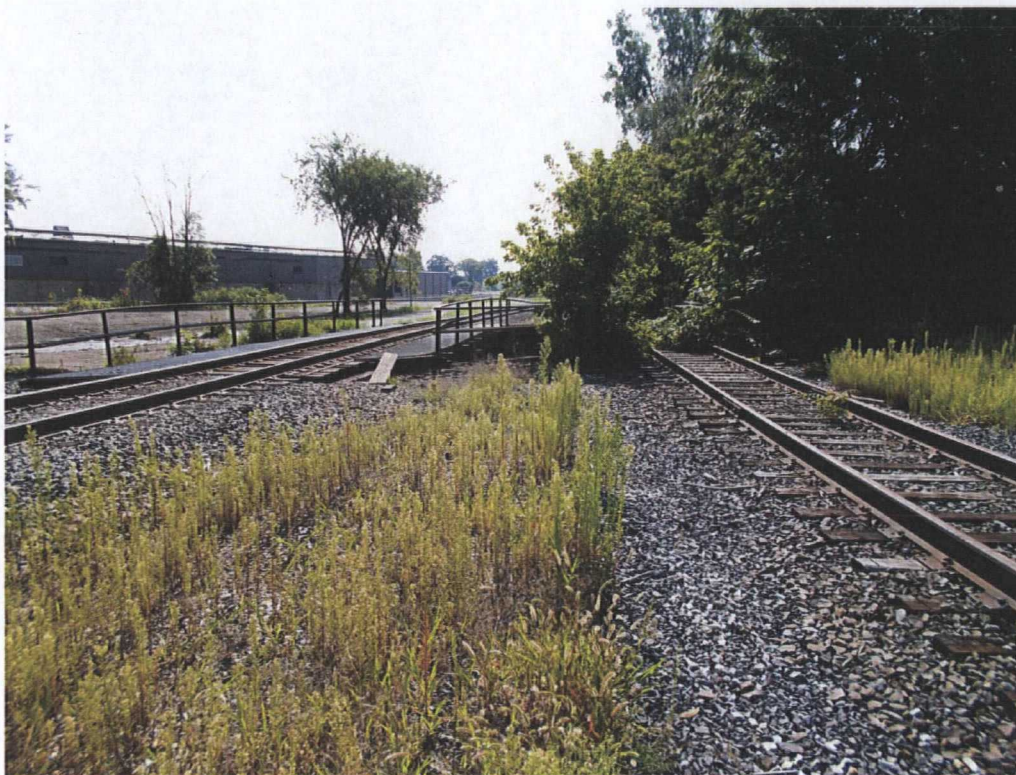
- The failed conduit along the north side of the structure appears to be unchanged.
- The structure does not appear to have been impacted during sediment removal.

Structure viewed from track level

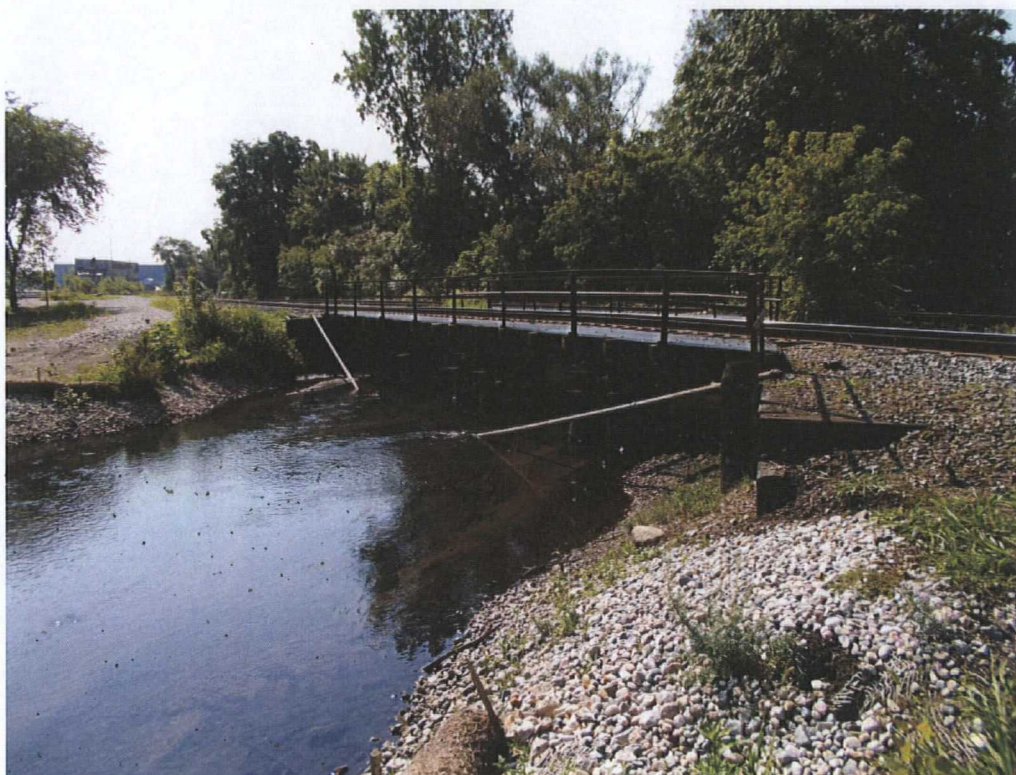
Elevation view of the structure

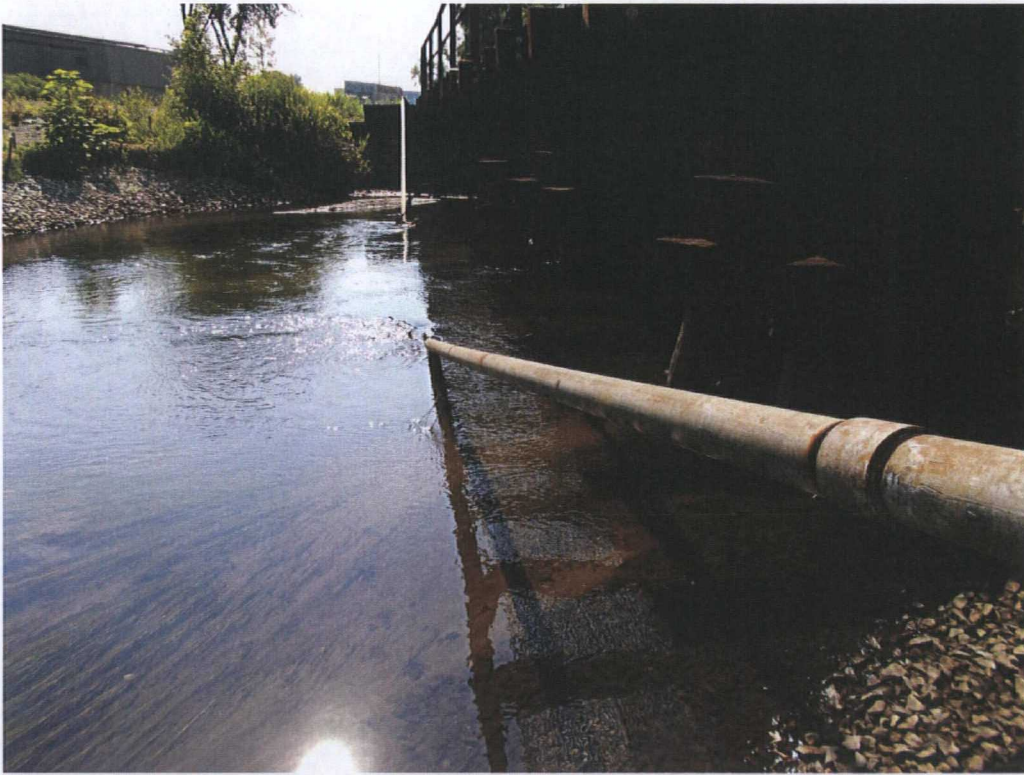
View of the failed conduit on the north side of the structure

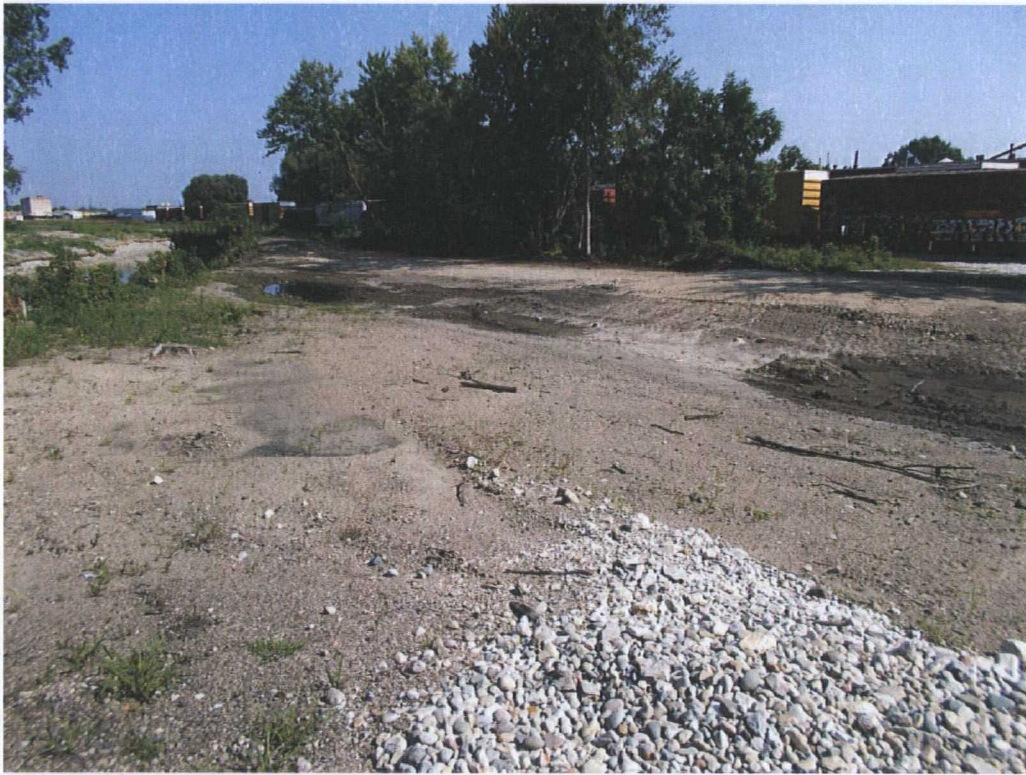
- The area has been cleared and the pole and guy removed.

View of previous pole and guy location

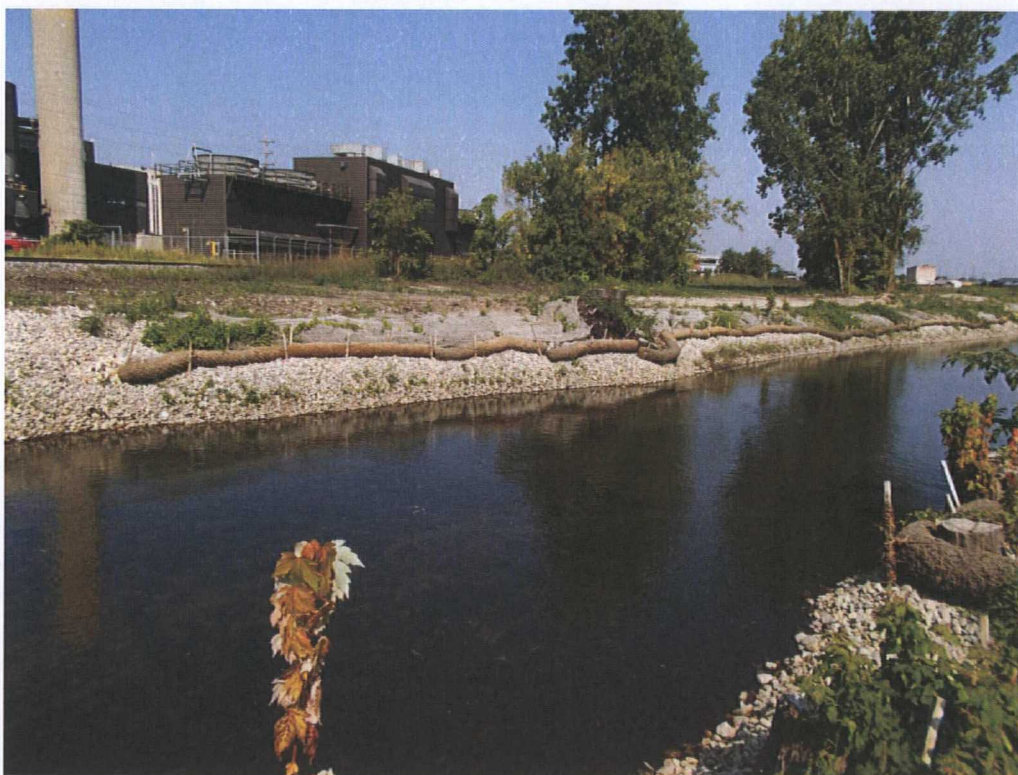
- The structure has been removed and bank restored.

View of the west bank in the area of the previous structure

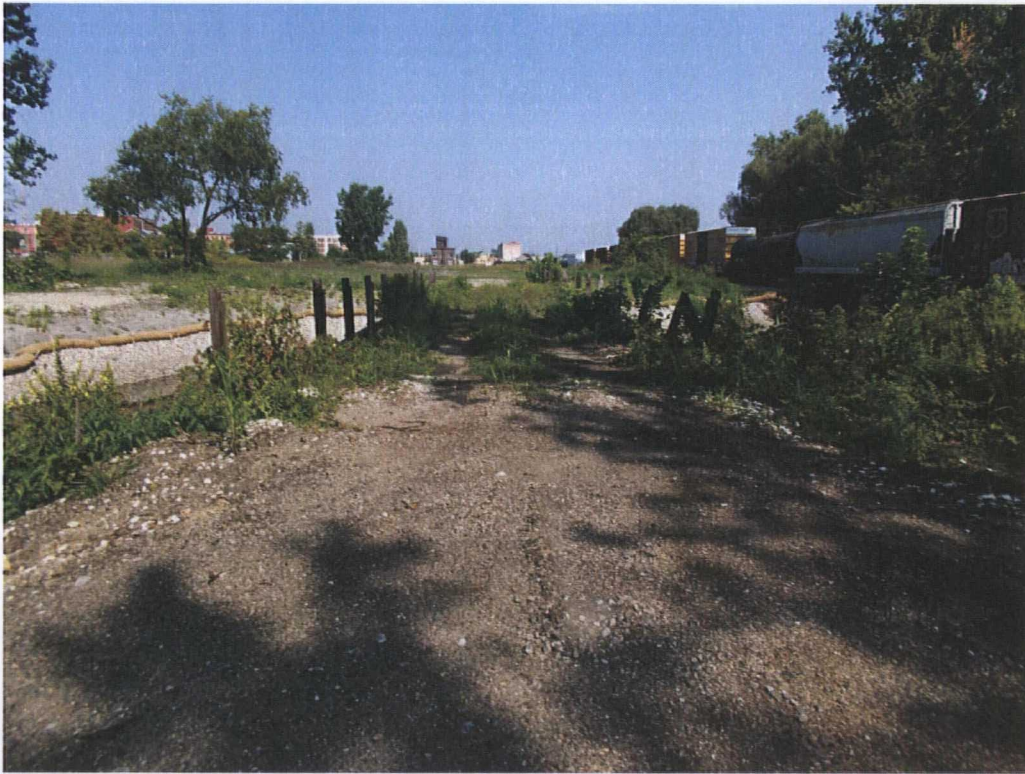
- Debris caught on the upstream side of the structure has been removed.
- The structure does not appear to have been impacted during sediment removal.

View of the structure looking north

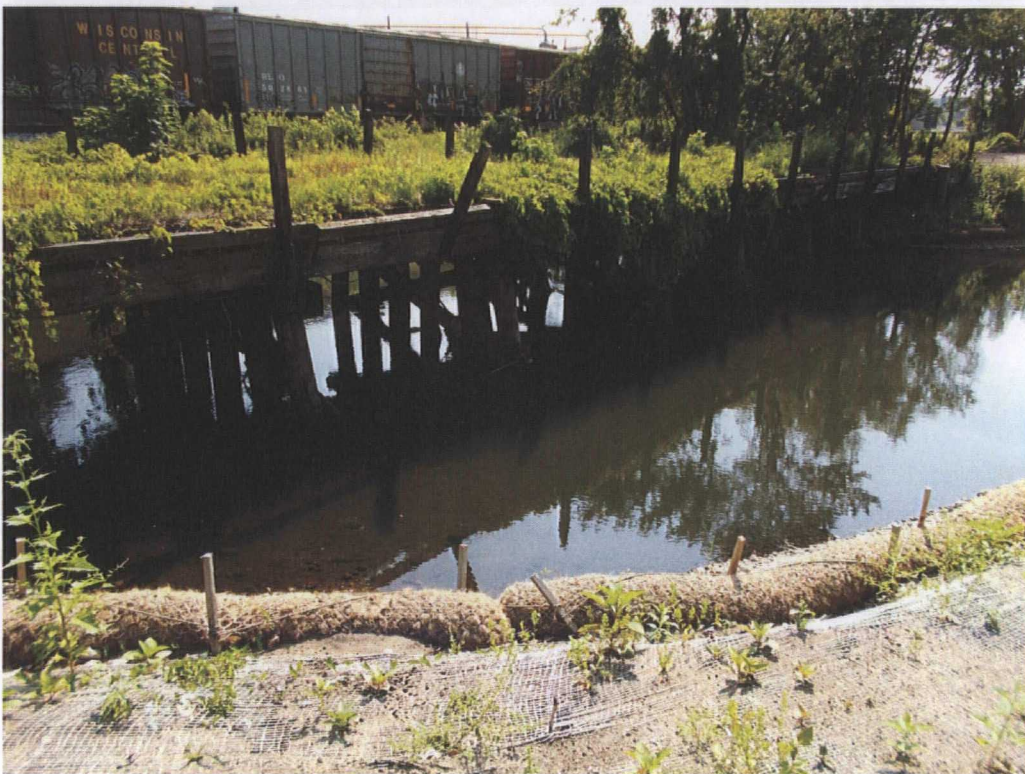
Elevation view of the structure from the west bank

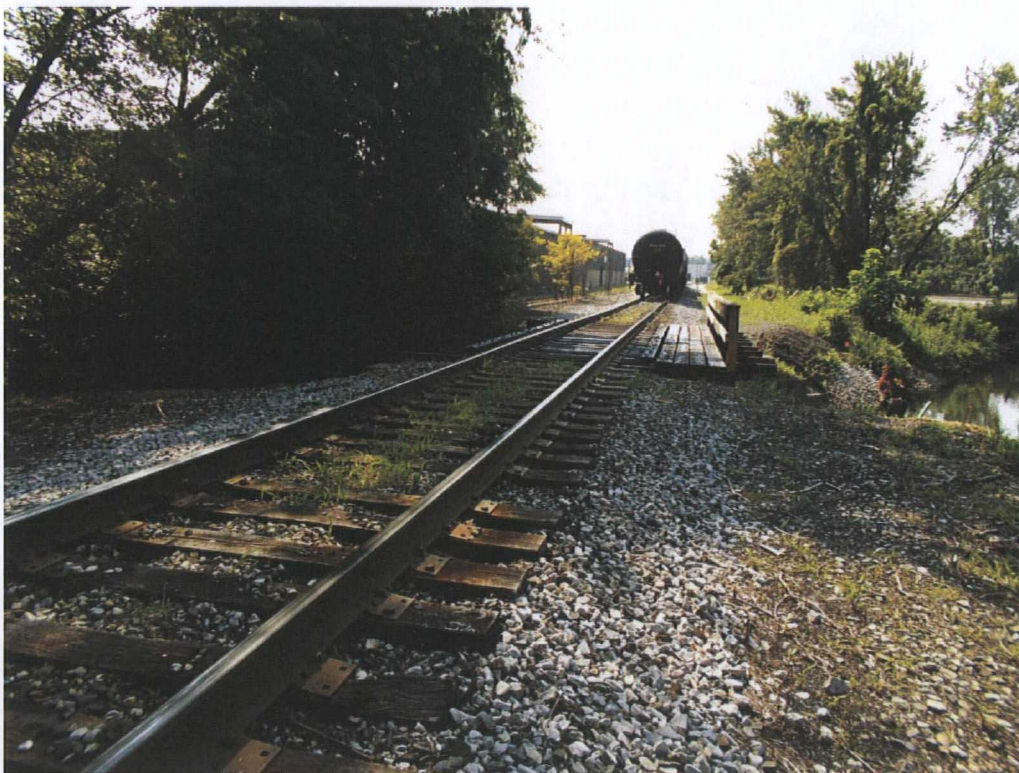
- The structure does not appear to have been impacted during sediment removal.

View of structure from approach track

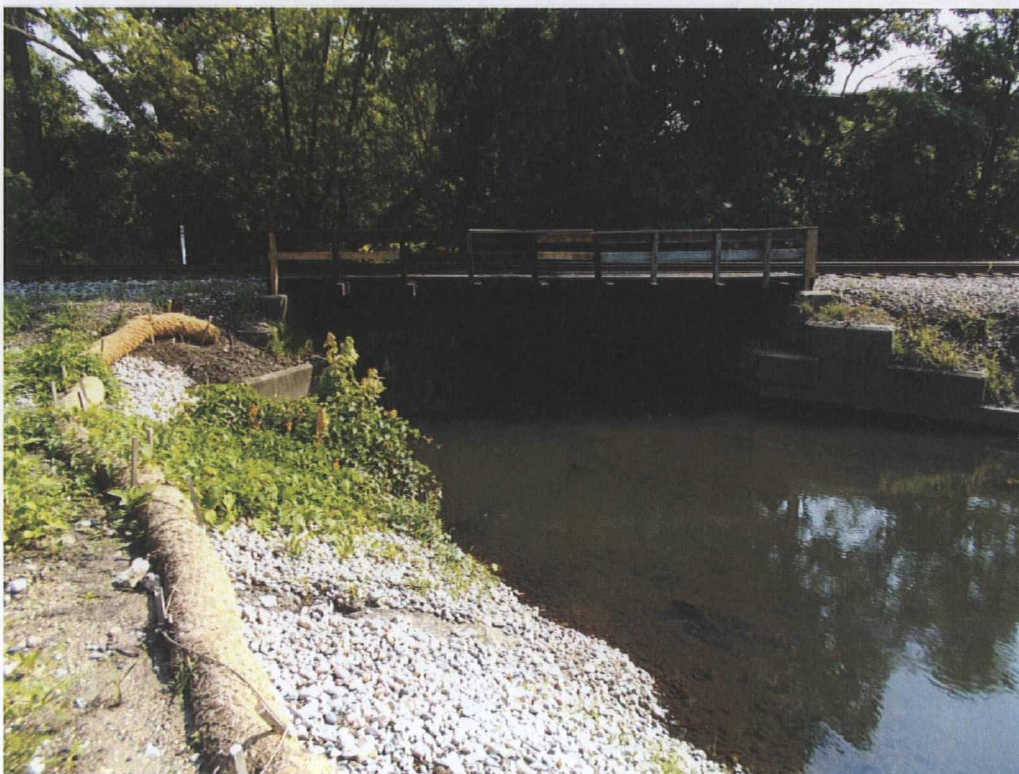
Elevation view of structure
